**Could Helston have historically been a port  
settlement? : *An analysis of available evidence  
and LiDAR remote sensing data cross  
referenced with a survey of the lower Cober/Loe  
valley***

Submitted by Peter Nicholls to the University of Exeter – Camborne School of Mines as a dissertation towards the degree of Master of Science by advanced study in Surveying, Land Environmental Management, September 2013

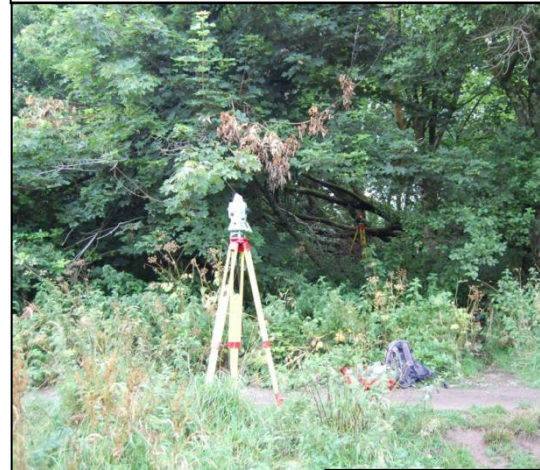
(Location: 165231.001mE 26671.3597mN)

**Figure 3.3a:** Site photograph illustrating denseness of vegetation and the difficulty it posed for surveying

data) was impossible with the equipment. This resulted in 'gaps' of information where certain areas were inaccessible, which effects the generalisation of height within the valley. Figure 3.3a shows an example of where a sighting could be made through a gap in the vegetation, however in many cases the foliage was so condensed and concentrated that detailing was impossible.
